Life Assessment of Corroded Superheater Tubes in a Powerplant Steam Generator

Chamaiporn Sudasna Na Ayudhya¹, Ruangdaj Tongsrri¹, Nuchthana Poolthong², Nakorn Srisukhumbowornchai², Veera Loha³,
Panya Srichandr², and Nandh Thavarungkul²

Abstract

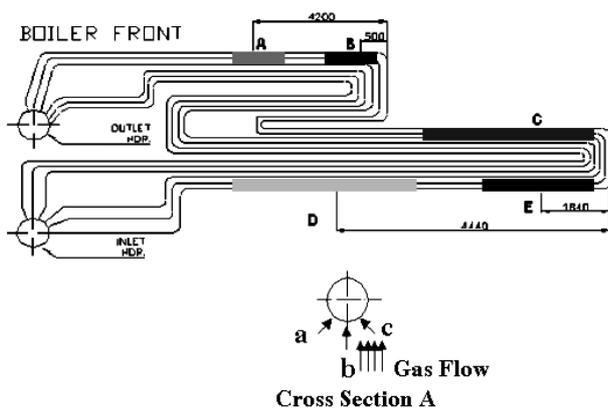
The tube investigated were taken from different sites of tertiary superheater coils at upper rows (position A, B, and C) and lower rows (position D and E) as shown in Fig. 1. Life assessment were estimated at the outer surfaces of the tubes. There was variation of thickness in an individual tube, thus wall thicknesses were usually observed at the positions marked by a, b, and c (Fig.1).

Fig. 1 Positions where the tubes were examined.

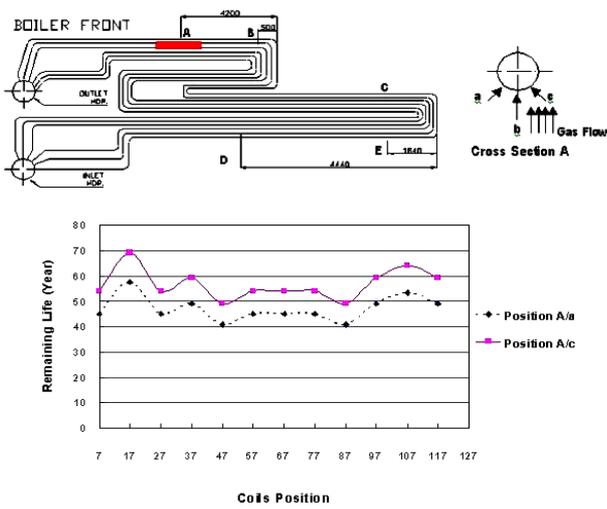
The values of estimated remaining life (ERL) of the superheater tubes varied with positions on the tube. The positions A, B, C, D, and E showed ERL values of 41, 22, 15, 6, and 5 years, respectively. The tube at lower rows (positions D and E) showed little ERL as shown in Fig. 5 and 6 (Table 2). The tubes at upper rows (positions A, B and C) exhibited longer ERL as shown in Fig. 2, 3, and 4 and table 2. This is attributed to the fact that the tubes at positions D and E are exposed to severe environment (higher temperature and higher content of corrosive combustion residues). Combination effect of temperature and

Fig. 2 Remaining life of the superheater tubes position A/a and A/c

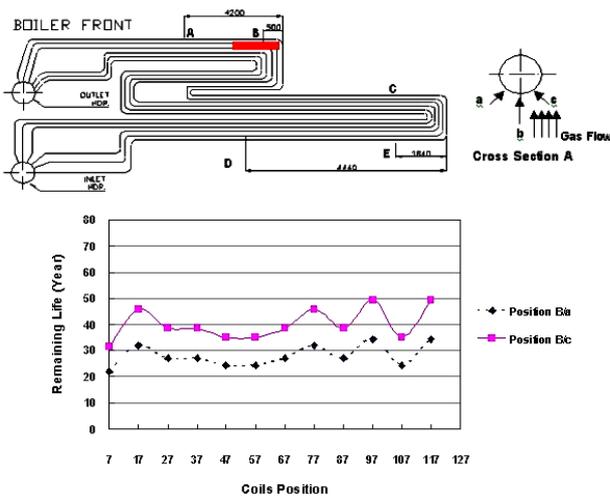
Fig. 3 Remaining life of the superheater tubes position B/a and B/c

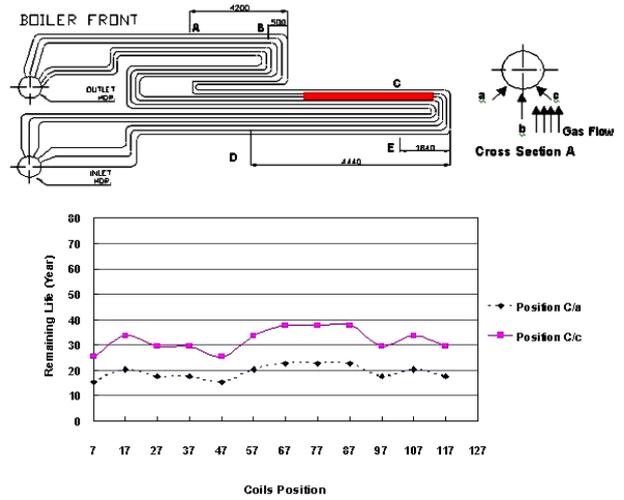
Fig. 4 Remaining life of the superheater tubes position C/a and C/c

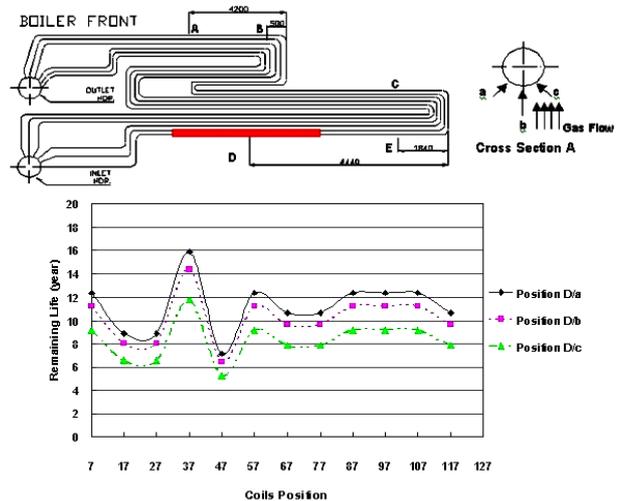
Fig. 5 Remaining life of the superheater tubes position D/a, D/b and D/c

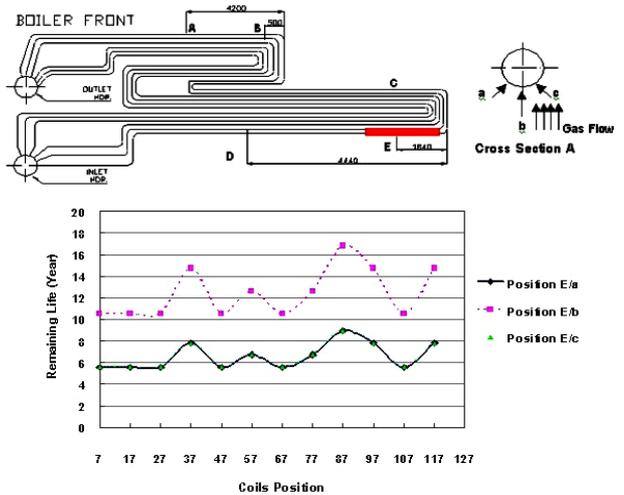
Fig. 6 Remaining life of the superheater tubes position E/a, E/b and E/c

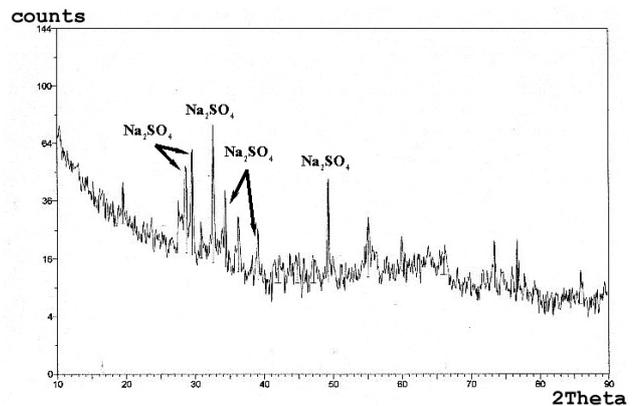
XRD patterns of the scales taken from severely corroded superheater tubes Nos. 20T and 80B are shown in Figs. 7 and 8, respectively. Interpretation of the patterns suggested that Na_2SO_4 compound was present in the scales from both tubes. During combustion of low-grade fuel oils, vapors of vanadium oxide (V_2O_5) and alkali metal sulfates (for, example Na_2SO_4 or $\text{Na}_2\text{O}\cdot\text{SO}_3$) are formed. These vapors, combine with other ash constituents, then deposit onto cooler component surfaces. Reactions between vanadium and sodium compounds result in formation of low-melting complex vanadates, which flux the protective oxide scale from the metal surfaces, accelerated corrosion attack [3].

The presence of Na_2SO_4 compound may confirms that corrosion on the superheater tube surfaces involves with molten salts. The low-melting point eutectic $\text{V}_2\text{O}_5\text{-Na}_2\text{SO}_4$ salts of may be formed with greater molar ratio than that $\text{V}_2\text{O}_5\text{:Na}_2\text{SO}_4$, so that some non-reacted Na_2SO_4 compound remains in the scales.

Fig. 8 XRD Pattern of a tertiary superheater tube No. 80B (Phase identification using JCPDS 74-1738 card for Na_2SO_4).

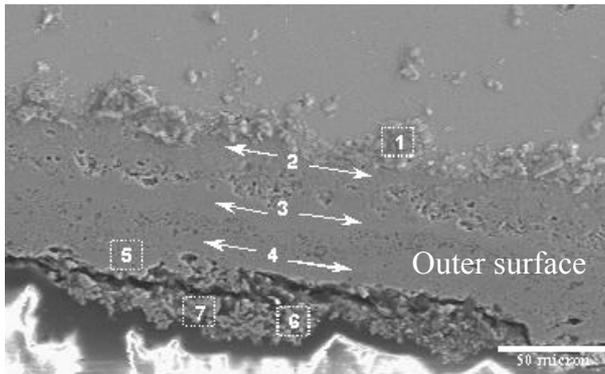
Chemical analyses using EDS, performed on the scale (Fig. 9), revealed that high chromium contents were observed in the scale inner layers Nos. 2 and 3. Depletion of chromium in matrix (region No. 1) near the scale inner layers was observed. The scale outer layers Nos. 4 and 5 and the attacked surfaces of the scale (regions Nos. 6 and 7) showed low contents of chromium but high contents of vanadium. Porosity in the scales

Fig. 9 Regions for chemical analyses of the tube No. 80B using EDS.

This indicates that the scale inner layers may still have capability to protect the metal matrix from corrosion attack whereas the scale outer layers loss some chromium due to corrosion attack. High vanadium contents in the outer layers and the attacked surfaces of the scales may indicate deposition of complex vanadates. Fluxing of protective chromium oxide film by low melting point vanadates results on loss of scale mass.

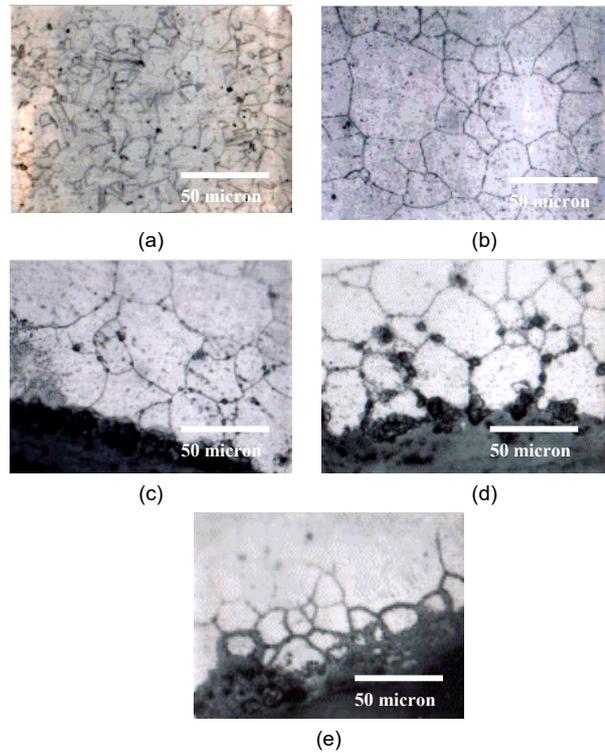
From the series of micrographs (Fig. 10) taken from different superheater tubes at different locations investigated, possible mechanism for high-temperature corrosion may be purposed as follows. In new superheater tubes, microstructures exhibit fine austenitic grains with few precipitates (Fig. 10(a)). After the tubes have been in service at high temperatures and under high pressures for a certain time, grain growth and precipitation of fine carbide particles either in grains or at grain boundaries will occur (Fig. 10(b)). Exposure to elevated temperatures and high pressures for longer times will cause abundant carbide precipitation at grain boundaries (Fig. 10(c)). Coarsening of carbide particles will be assisted thermally by diffusion of carbon and chromium, along grain boundaries or through the matrix of the grain, to the growing particles (Fig. 10(d)).

Chromium depletion in grains may due to dissolution of chromium carbide particles in the matrix and diffusion of chromium and carbon atoms to grain boundaries. Coarsening of chromium carbide particles at grain boundaries will reduce corrosion resistance of the grain boundaries themselves and/or of the matrix adjacent to grain boundaries. When the protective chromium oxide film is destroyed, corrosion attack will occur according to two modes. In the first mode, the metal matrix is fluxed by molten salts causing two wastage plats at about 2-

o'clock and 10-o'clock positions (3). In the second mode, the broken chromium oxide film cannot be repaired thus oxidation of iron along grain boundaries are accelerate (Fig. 10(e)).

Fig. 10 Series of microstructural changes according to the mechanism for high-temperature corrosion of the superheater tubes (x500).
