## Fatigue Crack Growth Behavior of Magnesium Alloy AZ61 under Corrosive Environment

### Abstract

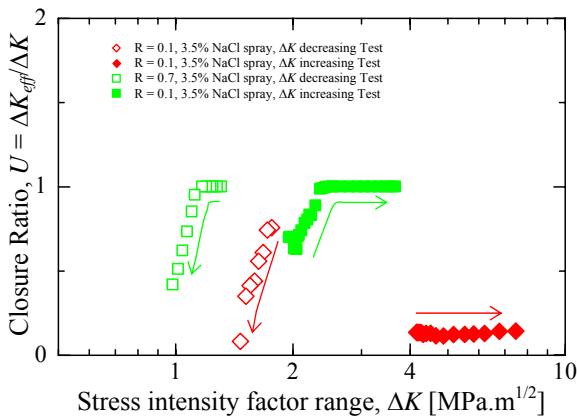
From the crack closure measurements, relationship between  $U$  and  $\Delta K$  is shown in Fig.8. As can be seen from the figure, two separated curves were also found in this relationship. Especially, for the case of  $\Delta K$ -increasing test under  $R = 0.1$ , the crack was almost closed, which seemed to be unusual compared to commonly-known behavior of metallic materials without corrosion influence.

**Figure 8.** Relationship between crack closure ratio and  $\Delta K$  of magnesium alloy AZ61 under 3.5% NaCl spray environment.
